MS355 Overview and Specifications

The MS355 is a multi-gigabit switch line designed to help prepare Organizations for the increased bandwidth requirements of the upcoming 802.11ax wireless standard with high-count mGig switch ports and increased switching capacity to meet the demands of next generation access points. Networks with sizeable wireless deployments such as universities, hospitals, and large public complexes like transportation centers can all benefit from the increased bandwidth capabilities of the MS355.

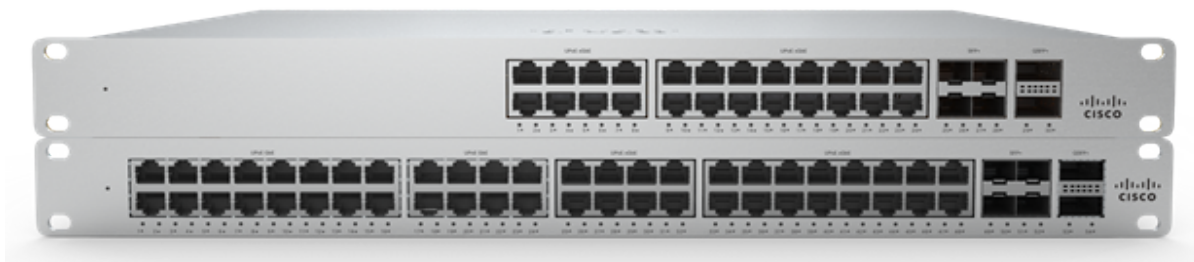
With 4 different models, each with multiple mGig RJ45 ports capable of negotiating up to 10Gbps, 40G QSFP+ ports, and dedicated 100G hardware stacking ports, the MS355 line is fully ready to support the future deployment of 802.11ax wireless infrastructure across a variety of different environments.
